Home Exterior & Roof Inspection / Maintenance Report

Property Referenced:
1 Main Street
Happytown, USA 01234

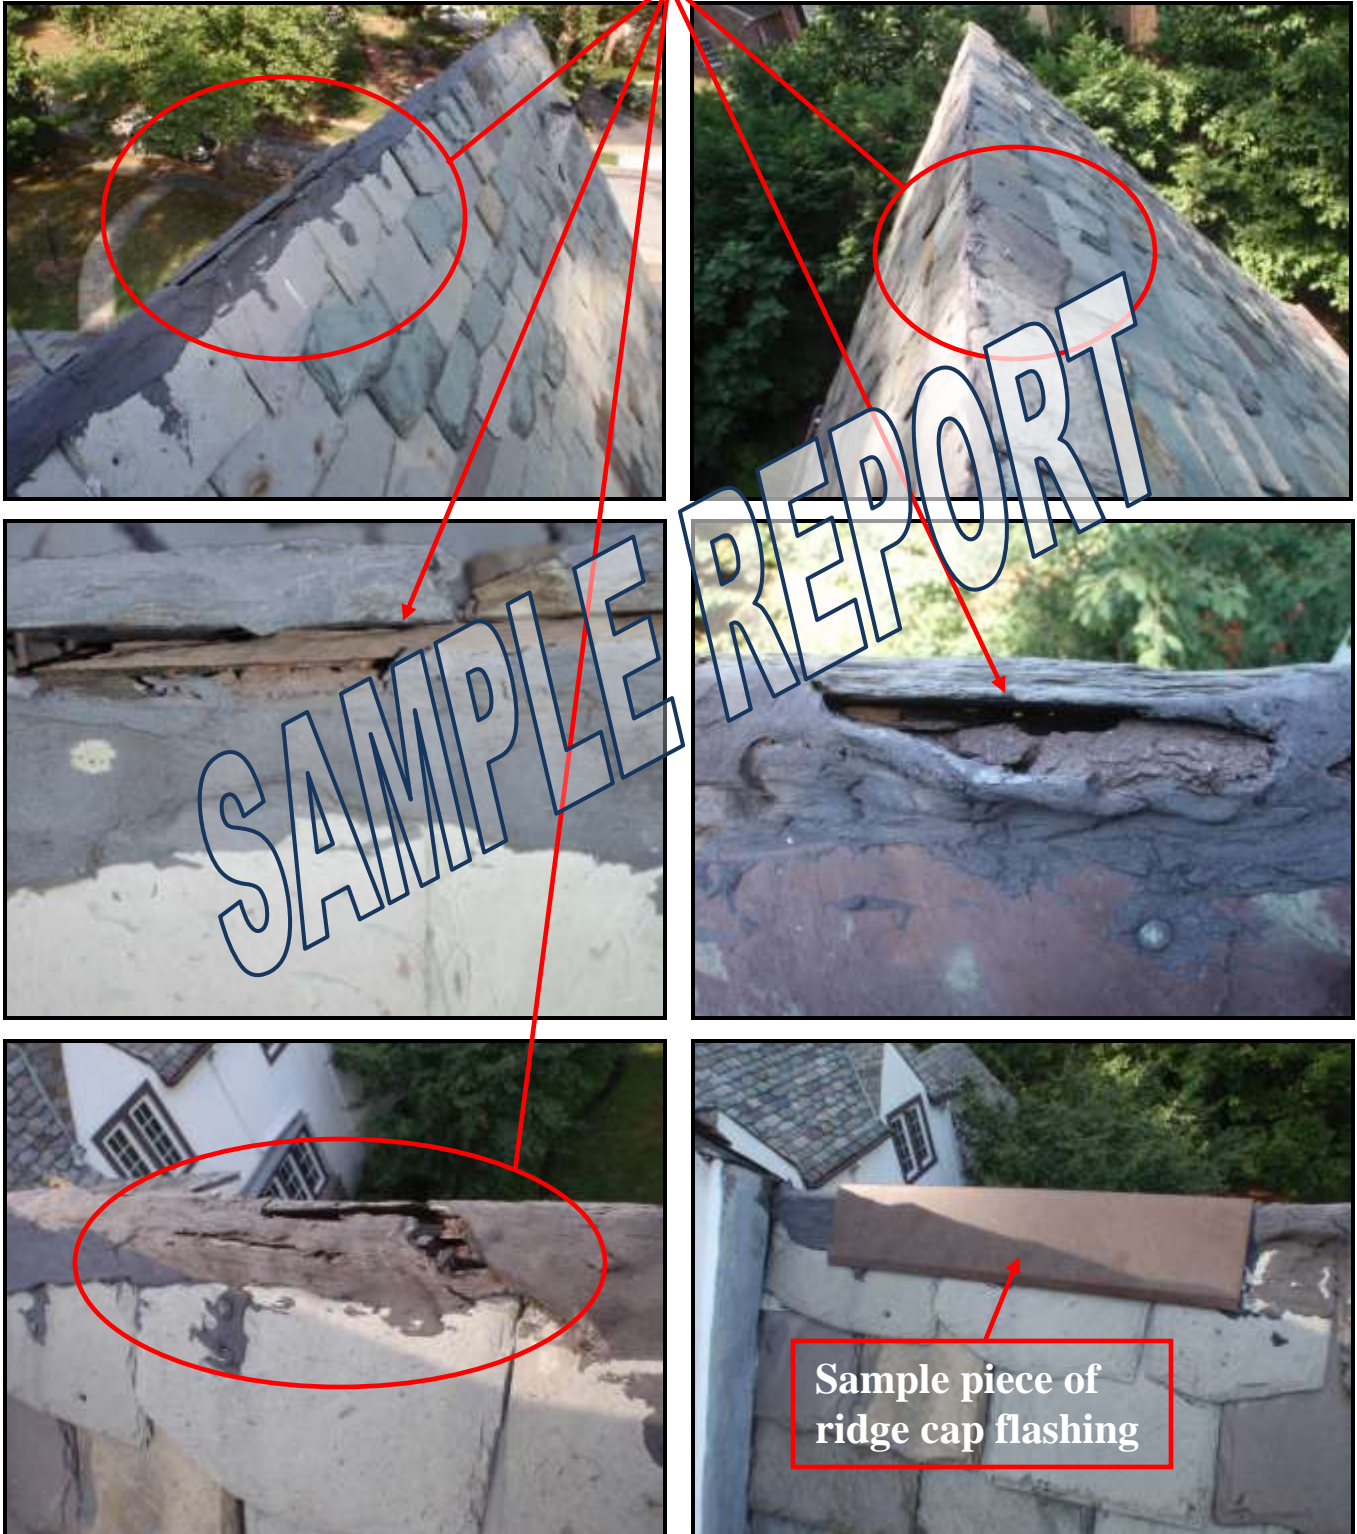
1. Slate roof is in very good condition; however there are many areas at the ridge where the cement is split wide open & nails backing out (this will allow water infiltration and can cause more extensive damage)

1. Dig out & re-cement all ridges or install ridge cap flashing
 2. Pull & repair exposed nails along the remaining eaves of the house
 3. Install custom spout head & splash guard or a diverter at lower end of front valley to contain water overflow
 4. Install snow rails at front valley to hold back & contain snow & ice above the front entry door.
- *Your roof is in good condition at this time. Regular inspection and preventative maintenance can prevent leaks and other roof related problems, protect your home's interior and extend the life of your roof.*

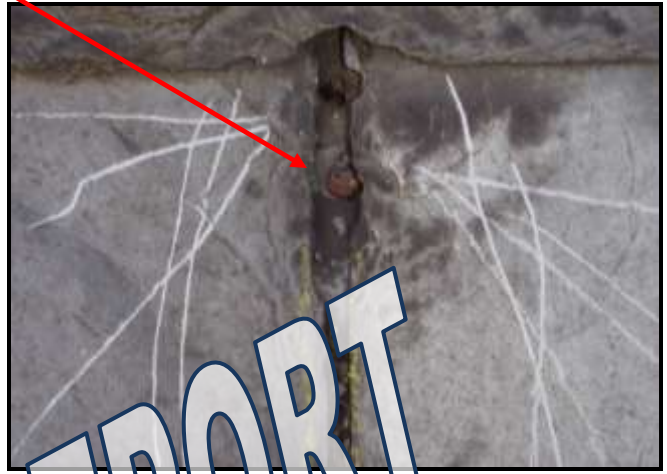
2. Eave slate all around house have been nailed through; probably done when old gutter screens were installed; these nails are rusted and difficult to find (these can allow water to drip through at the eaves and cause leaks)

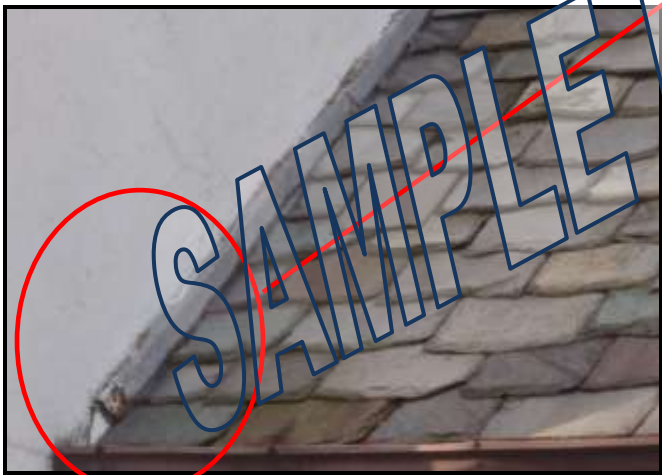
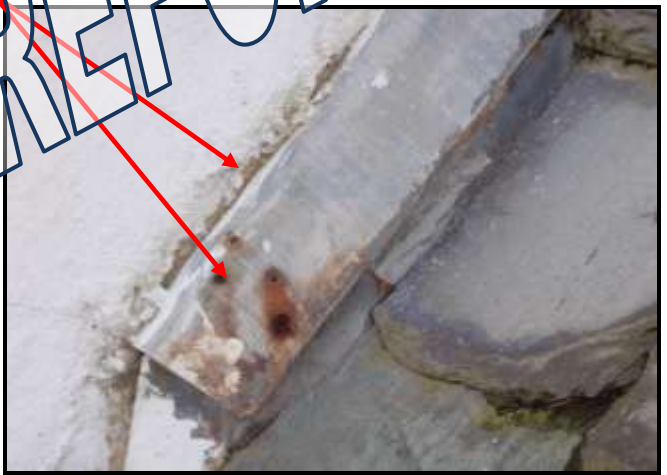
3. Caulk at wall flashings was split or missing; there are a few nail holes in the flashing also

1. Replaced two broken slates
2. Pulled exposed nails at bottom course of slate above leak area & flashed holes
3. Caulked wall flashings
4. Cemented open spot at ridge

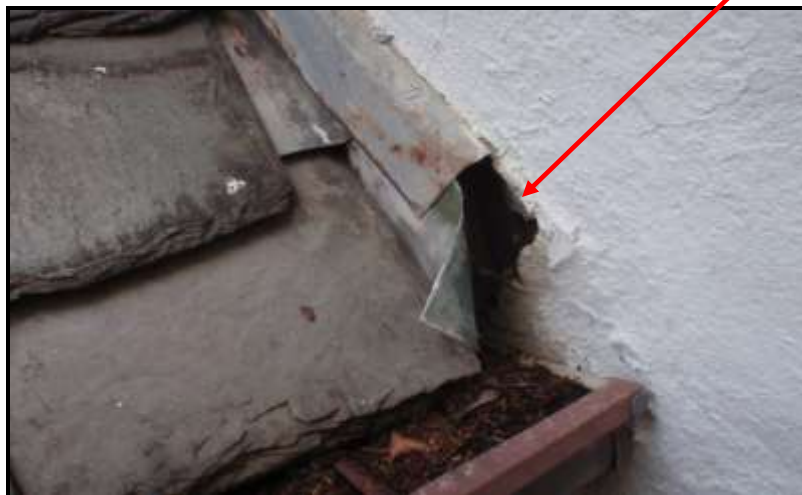
4. There is a hole behind one area of wall flashing that is missing
