Home Exterior & Roof Inspection / Maintenance Report

Property Referenced:
1 Main Street
Happytown, USA 01234

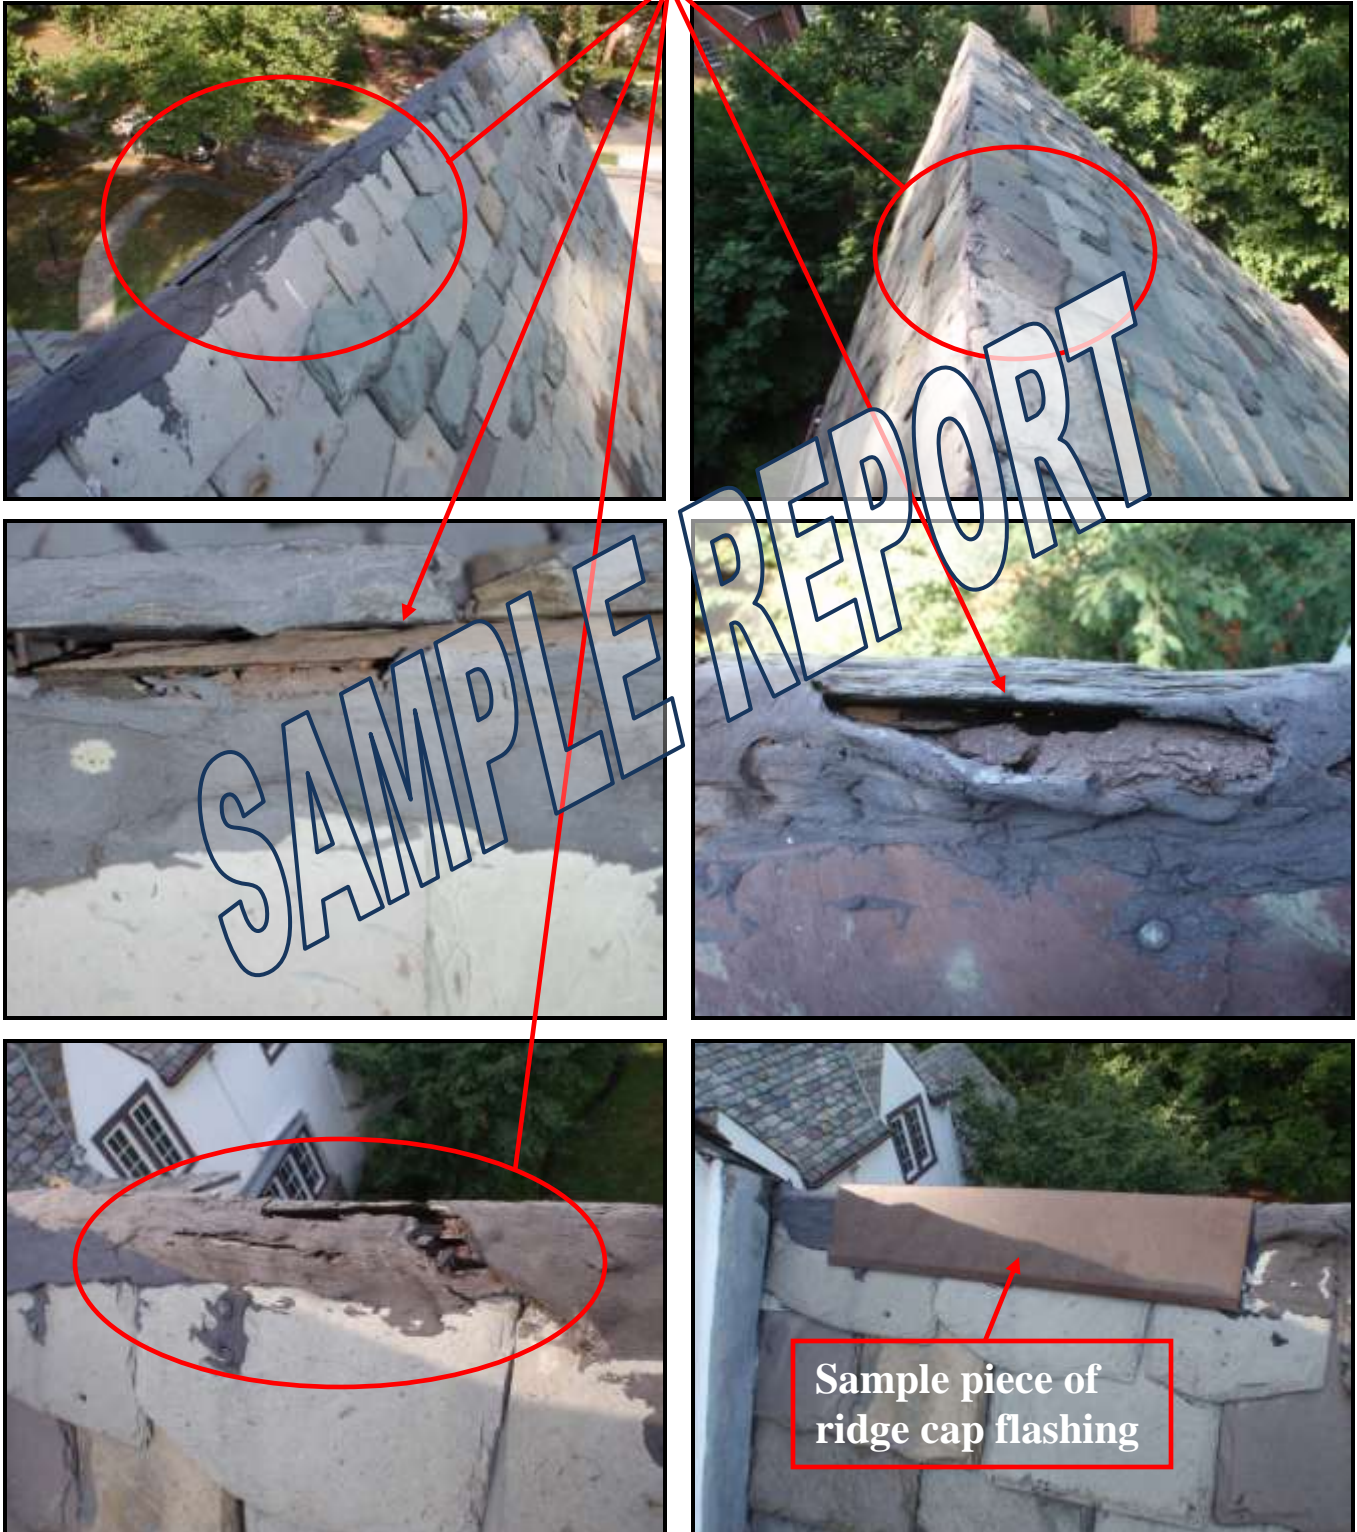
1. Slate roof is in very good condition; however there are many areas at the ridge where the cement is split wide open & nails backing out (this will allow water infiltration and can cause more extensive damage)

1. Dig out & re-cement all ridges or install ridge cap flashing
 2. Pull & repair exposed nails along the remaining eaves of the house
 3. Install custom spout head & splash guard or a diverter at lower end of front valley to contain water overflow
 4. Install snow rails at front valley to hold back & contain snow & ice above the front entry door.
- *Your roof is in good condition at this time. Regular inspection and preventative maintenance can prevent leaks and other roof related problems, protect your home's interior and extend the life of your roof.*

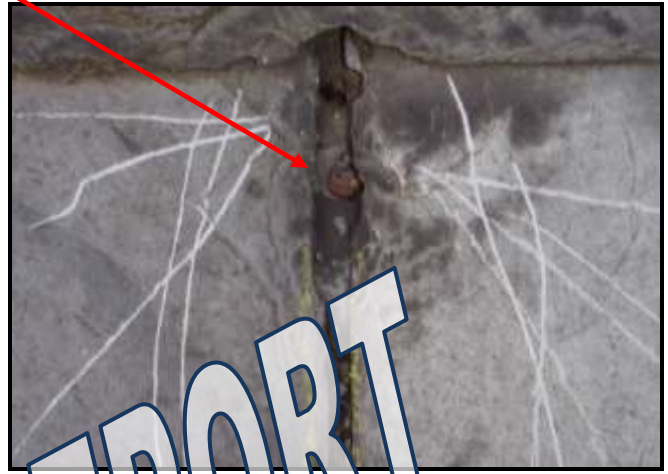
2. Eave slate all around house have been nailed through; probably done when old gutter screens were installed; these nails are rusted and difficult to find (these can allow water to drip through at the eaves and cause leaks)

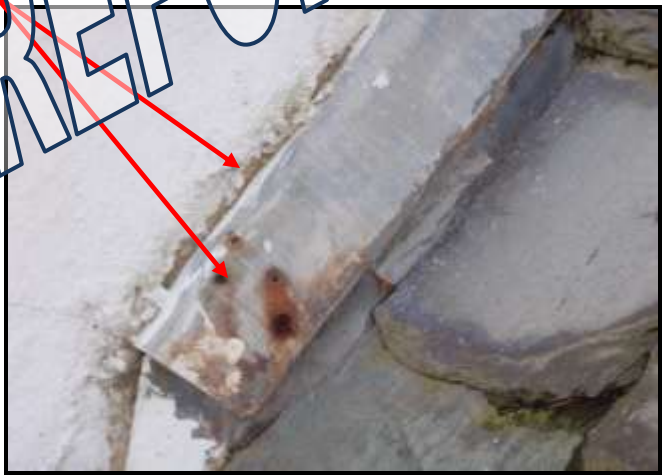
3. Caulk at wall flashings was split or missing; there are a few nail holes in the flashing also

1. Replaced two broken slates
2. Pulled exposed nails at bottom course of slate above leak area & flashed holes
3. Caulked wall flashings
4. Cemented open spot at ridge

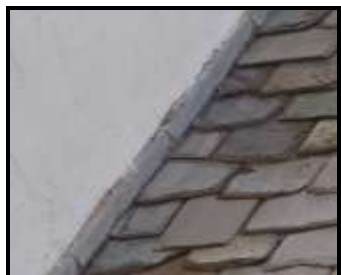
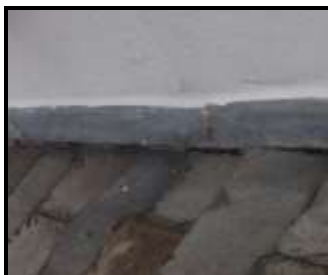
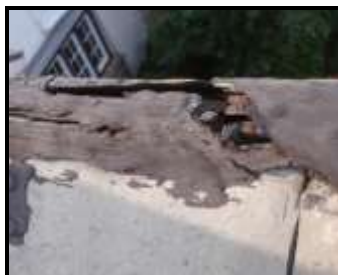
(before)

(after)
